Hazard Alert

No: 1605/004
Date: May 2016
CAMs Number: 043225

Historical Information leads to Assumptions

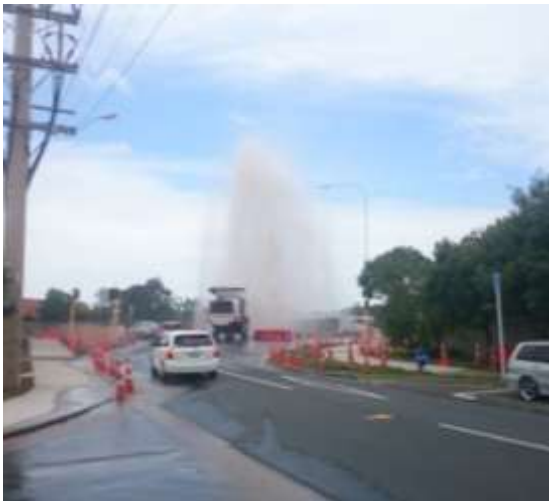
Whilst milling out existing pavement (295mm depth), the Fulton Hogan Wirtgen 2.2 metre wide miller hit the existing Watercare 425mm diameter steel bulk water main, damaging a section approximately 100mm in diameter.

The network was live and had a residual pressure of 16 bars, which led to an initial fountain/geyser some 10-15 metres into the air, until such time as a methodology was developed on site to reduce the visual and traffic impact until the utility owner repair team could turn up.

The service strike led to a large volume of (dirty) water discharging into the stream.

Approximately 3m of steel pipe required replacement; there was no localised loss of potable water supply; and the incident attracted some media attention.

The team used service plans, mark outs and a digging checklist, however they did not pot hole and based their information provided by the mark out person that indicated the service was at a depth of 800mm – located 8m away from mill area.

Other Fulton Hogan teams had worked in and around the water main over the preceding months and knew that the pipe was shallower, however this information was not

shared and the as-builts that were completed during this work were not left on site for the Engineers to refer to later on in the Project.

The service plans obtained from the utility owner did not take into account the work that had been done on the Project to date and, without the as built plans, the Engineer and team were using assumptions.

The section of road where the service was struck was considerably lower than the sections before and after due to historical works thus making the depth marked on the road (depth was confirmed as 800mm 8m away from strike area).

- Establish a system to ensure information and drawings from various work crews are collected, retained and disseminated for the duration of the project to ensure planning can consider all relevant and up to date information.
- Establish a system to ensure as built information from excavations and installations are collected, retained and made available throughout the duration of the project so it can be used in conjunction with service plans obtained from utility owners when completing the digging checklist.
- Update page 1 of the Digging Checklist to include a requirement for the Engineer to check project as-built information to complement externally sourced service plans and forward to CRG for consideration.
