# SAFETY ALERT

**Subject:** Ensuring Truck Outrigger Legs are Secured

**Date:** 21 October 2013

**Site** Crestmead, Brisbane, Australia

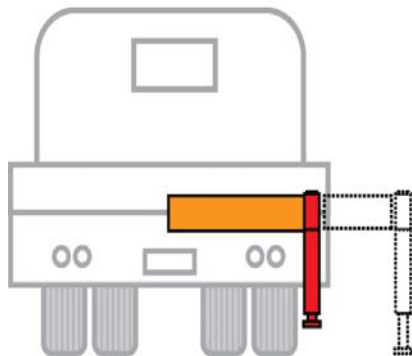
A semi-trailer with a truck mounted hydraulic crane was returning to its depot when the passenger side crane outrigger leg extended 1.5m as it turned a corner. The truck was operated by a trucking company contracted by Stramit to deliver product. The truck was returning to its home depot, after having unloaded its load at a customer's site.

During this journey, the outrigger has come free from its "home" position.

The truck continued its journey with its outrigger leg extended, until it collided with a cyclist, who was fatally injured.

Outrigger came free from its "home" position whilst in transit

- Outriggers have to be locked into "home" position prior to transit
- Outriggers to be operated in accordance with manufacturers' guidelines

All crane mounted trucks operated as part of Fletcher Building's operations, shall have an audible alarm that will warn the driver if the outrigger leg is not secured in its travel position, prior to leaving a site, or should it slide out, while underway.
