SAFETY ALERT

Tools dropped from height

Thursday 17th September 2015

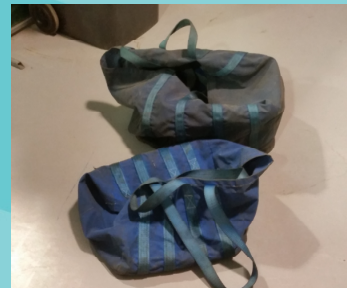
PHOTO:

Playing a significant outcome in the event was that the tool bag being used was unable to be sealed and therefore was not fit for purpose, even though it was tested and tagged.

- The bag could not be fully closed.
- The design of the working at height tool bag was not suitable for use in high winds.
- The hazard of falling tools from height and control measures were considered (the drop zone was in place) though this was only a primary mitigation and did not mitigate the possibility of someone entering the drop zone uninvited.

Non-compliant working at height tool bags

- All working at height tool bags must be able to be sealed completely and securely when hoisting gear to and from the nacelle or being carried on the turbine.
- Purpose made, sealable bags should be manufactured for items that may protrude from working at height tool bags.
- Undertake a review of the working at height tool bags being used by staff and contractors to ensure they meet this minimum requirement.
- Remove any non-compliant working at height tool bags from site.
- Ensure all hazards associated with the tasks are identified mitigations are in place.
- Assess wind speeds when using the crane.
